# Roof Condition Assessment Report

Sample Building

May 05, 2025 2:00 PM

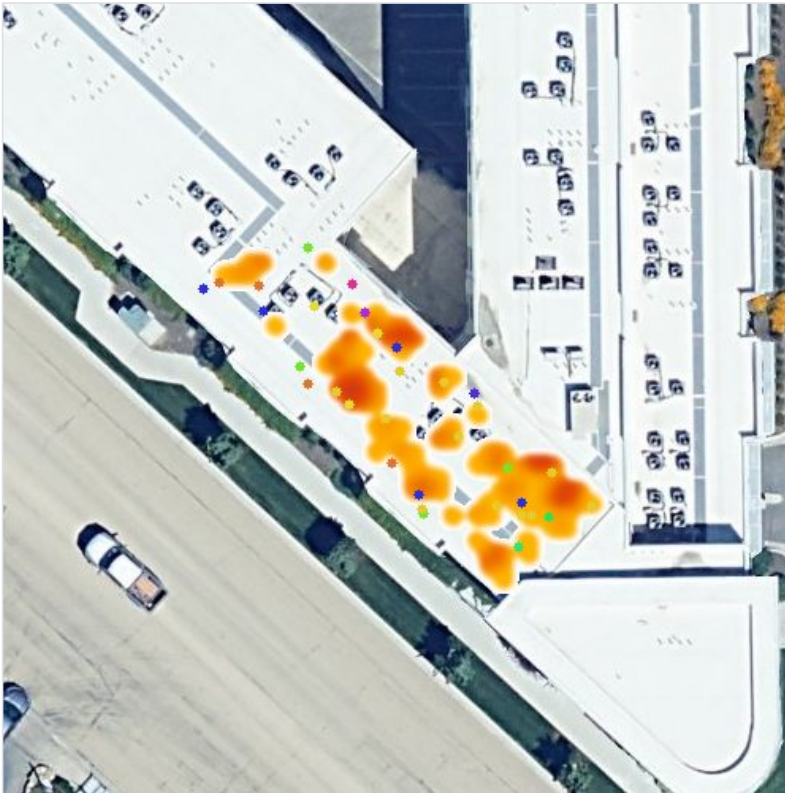
Figure 2.1. All observed deficiencies

Total assessed area: 2,169 sq.ft.

Metric	Building
Moisture	10.61%
Risk Level	Medium-Risk
RCI	57
Wet Area	230 sq.ft.
Remaining Life	2 years

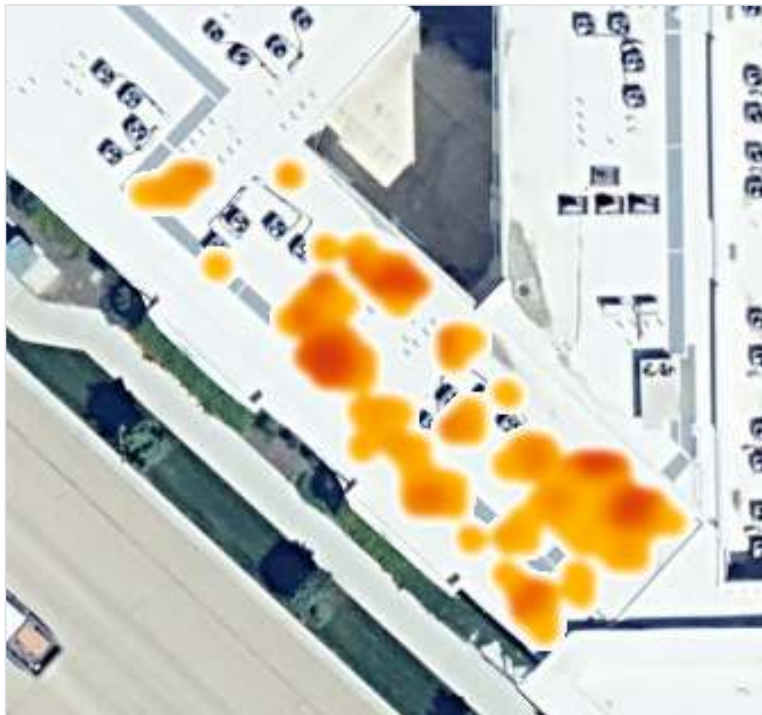
Figure 2.2. Below-membrane moisture

Metric	Value
Visual Condition Rating	<b>Good</b>
MRR Recommendation	Moderate Repair Needed
Remaining Roof Life	2 years
Roof Condition Index (RCI)	57
Moisture	10.61%
Section repair subtotal	\$4,088.08
Membrane Condition Index (MCI)	83
Flashing Condition Index (FCI)	82
Insulation Condition Index (ICI)	46
Assessed area	2,169 sq.ft.
Current Roof Age	8 years
Expected Roof Life	10 years

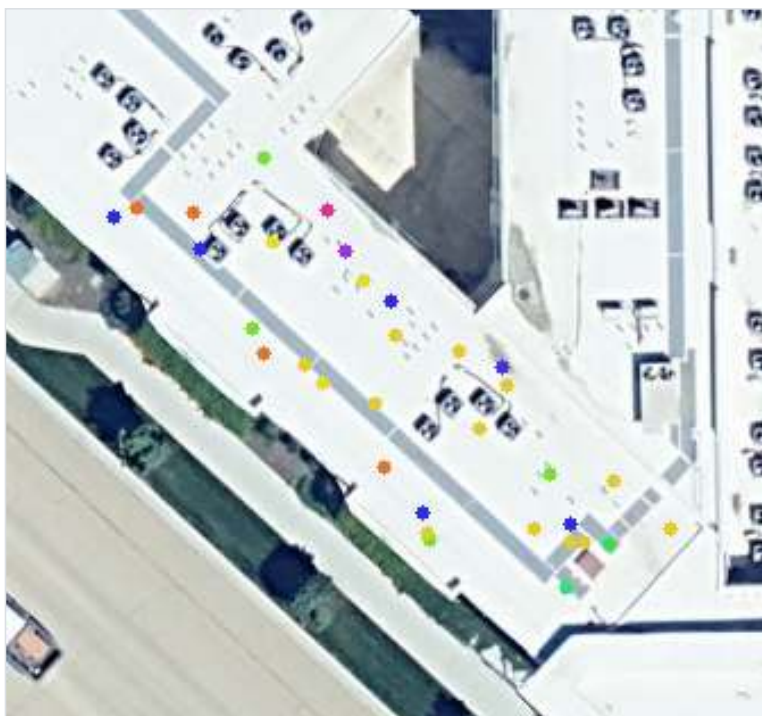
Figure 2.3. Visual defects

Color	Defect Type	Count
Yellow	Debris And Vegetation	16
Light Green	Flashed Penetrations	5
Blue	Patching	5
Orange	Base Flashing-Membrane Material	4
Yellow-Green	Defective Seams	3
Green	Holes Cuts And Abrasions	1
Light Green	Improper Equipment Supports	1
Purple	Ponding	1
Pink	Ridges	1
Pink	Surface Coating Deterioration	1

Defect Type	Severity	Qty	Unit	Total Cost
Debris Vegetation	Medium	5	EA	\$2,310.00
Flashed Penetration	Medium	3	EA	\$332.44
Patching	Low	100	SF	\$276.60
Ridges	Low	15	SF	\$247.05
Ponding	Low	1	EA	\$234.15
Base Flashing Membrane Material	Medium	20	LF	\$169.40
Surface Coating	Low	25	SF	\$164.50
Defective Seams	Medium	10	LF	\$144.60
Defective Seams	Low	5	LF	\$72.30
Patching	Medium	25	SF	\$69.15
Holes	Low	25	SF	\$67.89
<b>Total estimated repair cost</b>				<b>\$4,088.08</b>
