Visual Evidence Record

Supplementary to Assessment Report

Sample Building

ROOF CONDITION INDEX

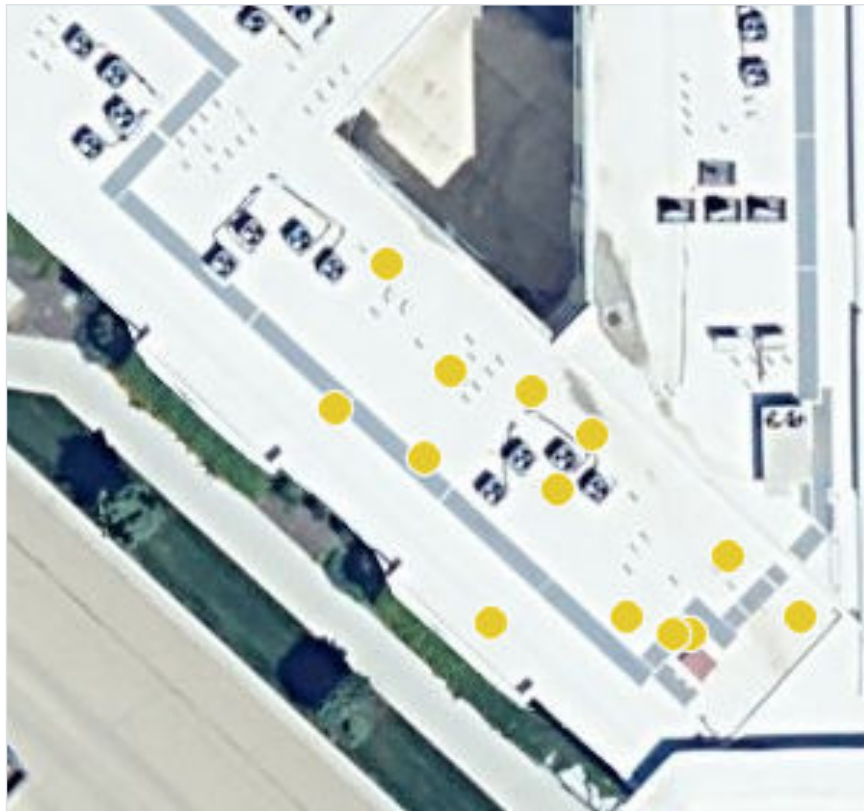
Figure 2.1. Debris And Vegetation locations

a Debris And Vegetation (High)

b Debris And Vegetation (High)

c Debris And Vegetation (High)

d Debris And Vegetation (Medium)

e Debris And Vegetation (Medium)

f Debris And Vegetation (Medium)

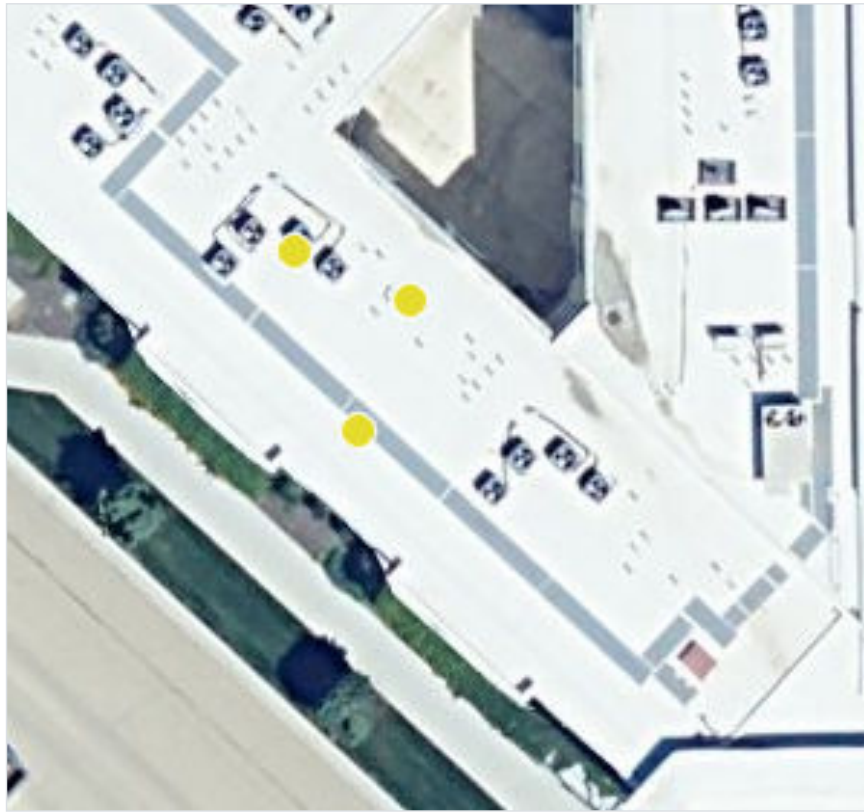
Figure 2.5. Defective Seams locations

a Defective Seams (High)

b Defective Seams (Medium)

c Defective Seams (Low)

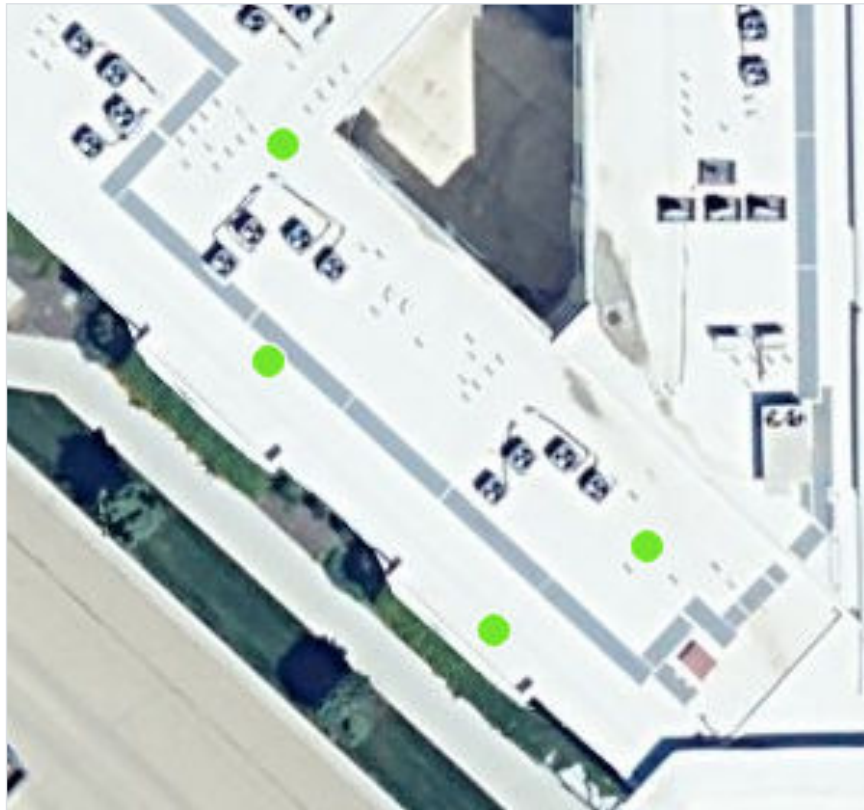
Figure 2.9. Flashed Penetrations locations

a Flashed Penetrations (Medium)

b Flashed Penetrations (Medium)

c Flashed Penetrations (Low)

d Flashed Penetrations (Low)

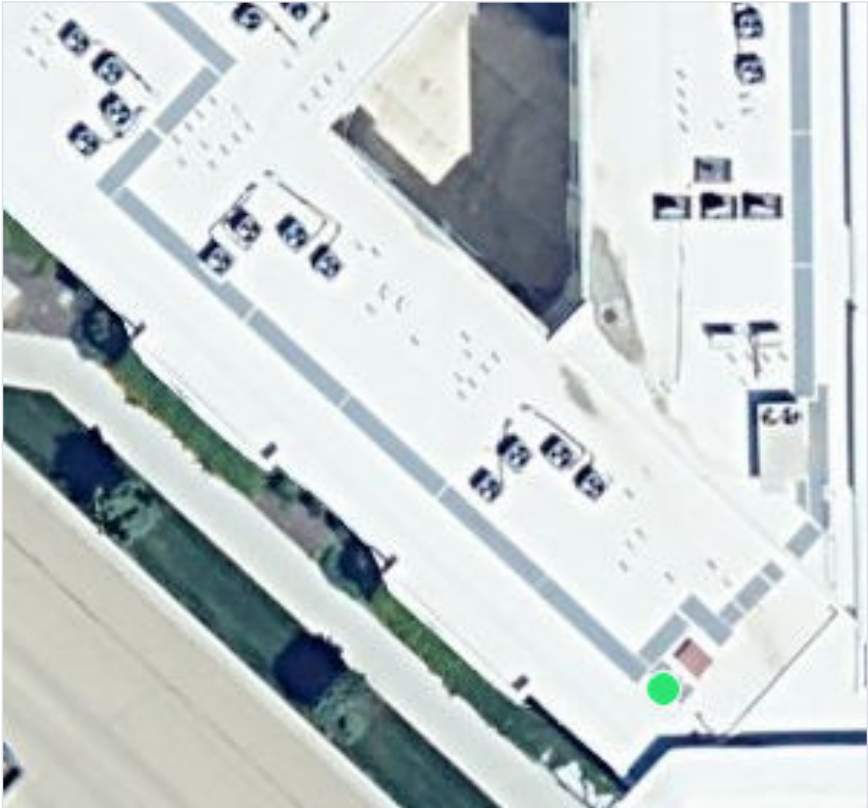
Figure 2.11. Improper Equipment Supports locations

a Improper Equipment Supports (Medium)

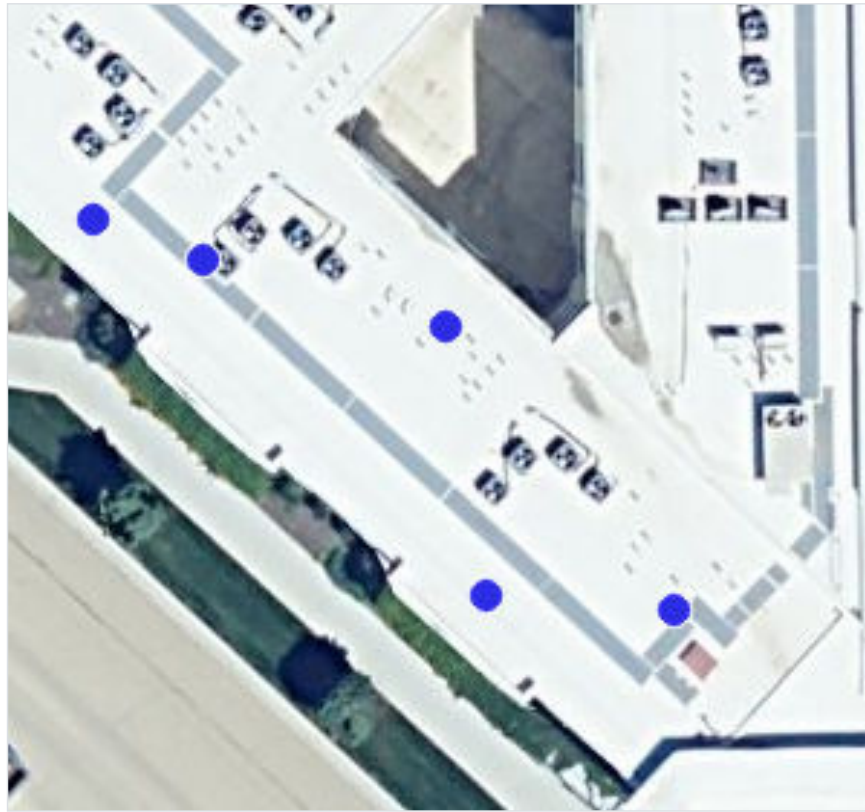
Figure 2.13. Patching locations

a Patching (Medium)

b Patching (Medium)

c Patching (Low)

d Patching (Low)

e Patching (Low)

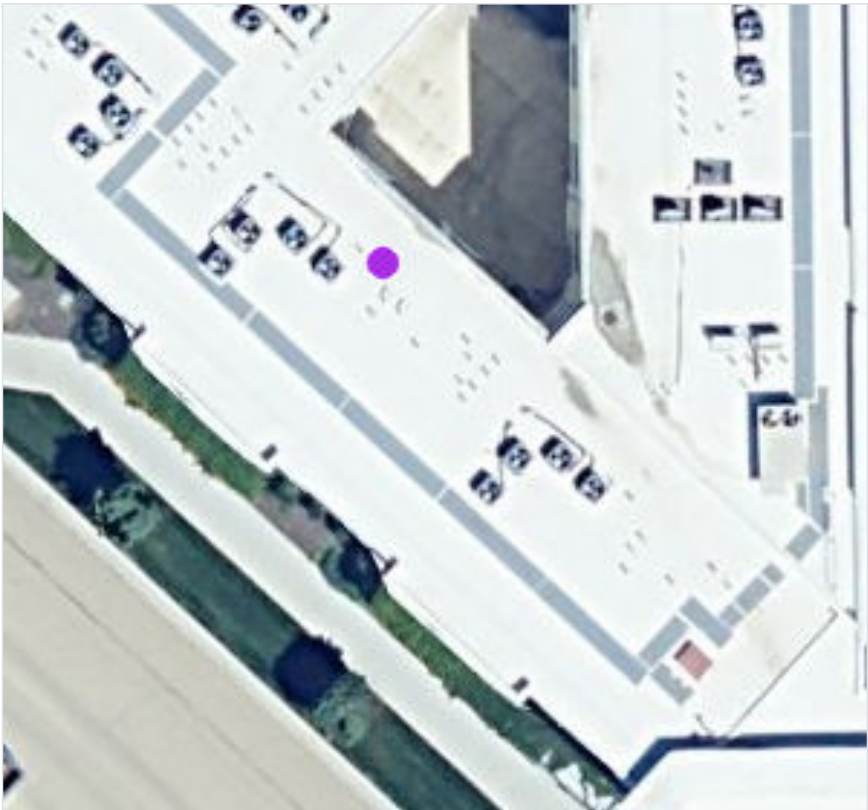
Figure 2.15. Ridges locations

a Ridges (Medium)

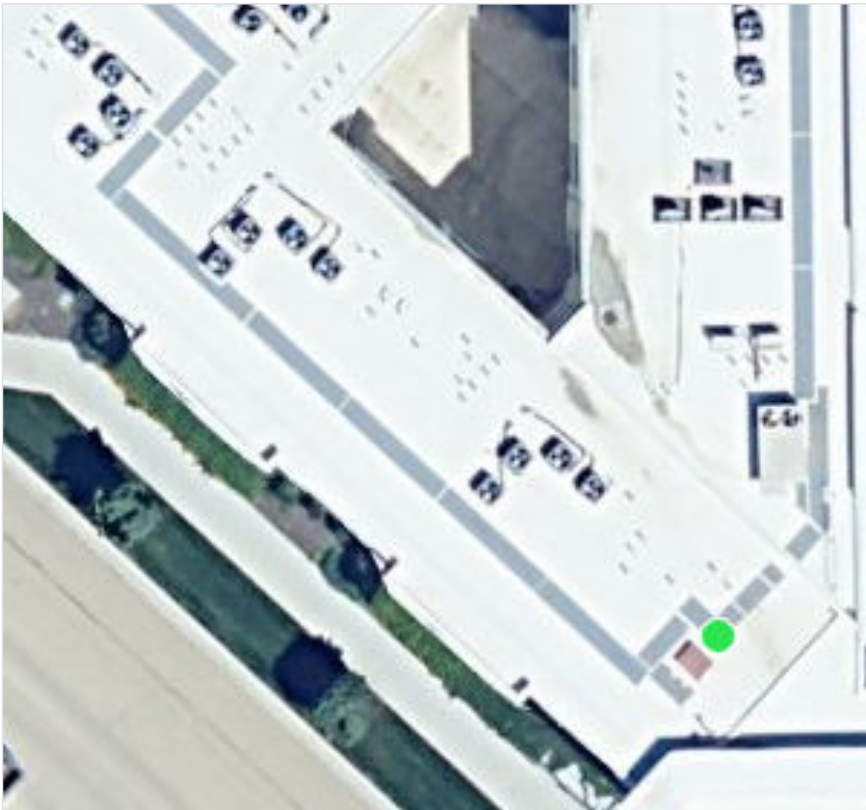
Figure 2.17. Holes Cuts And Abrasions locations

a Holes Cuts And Abrasions (Low)

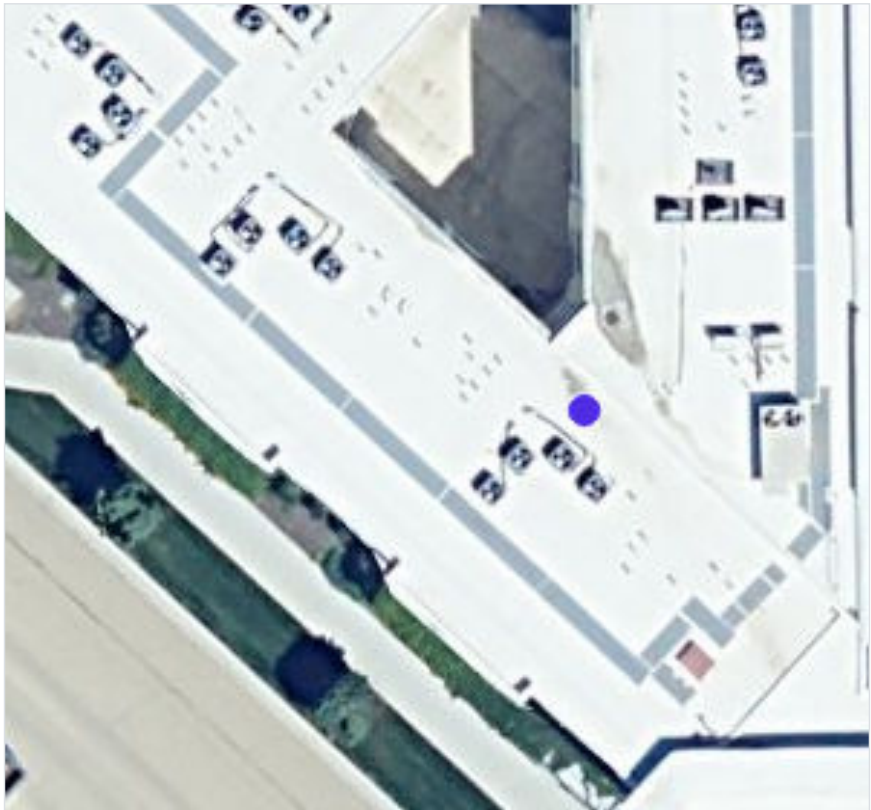
Figure 2.19. Ponding locations

a Ponding (Low)

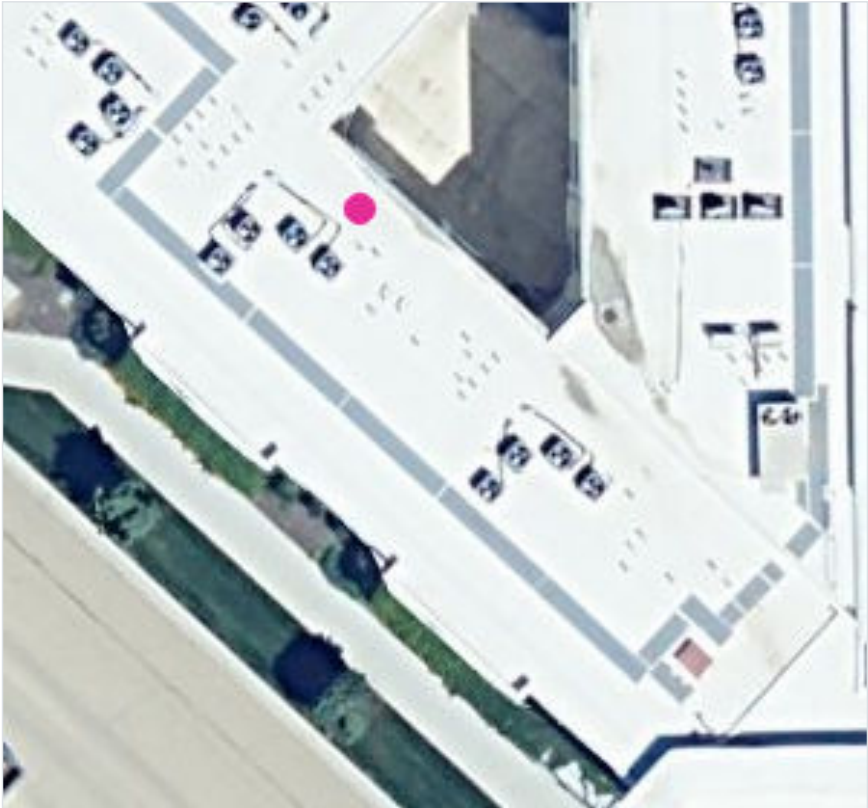
Figure 2.21. Surface Coating Deterioration locations

a Surface Coating Deterioration (Low)
